# VANDERBURGH COUNTY SURVEYOR'S

## 2008 ANNUAL REPORT

### REGULATED DRAINS

**Vanderburgh County Surveyor**

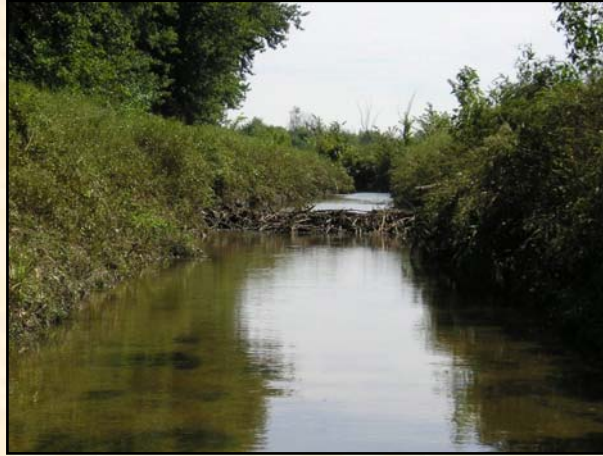
**Figure 1 Beaver Dam Along Eagle Slough**

1. Remove existing beaver dams
2. Implement a beaver population control program
3. Remove other existing obstructions
4. Implement stormwater runoff quality monitoring

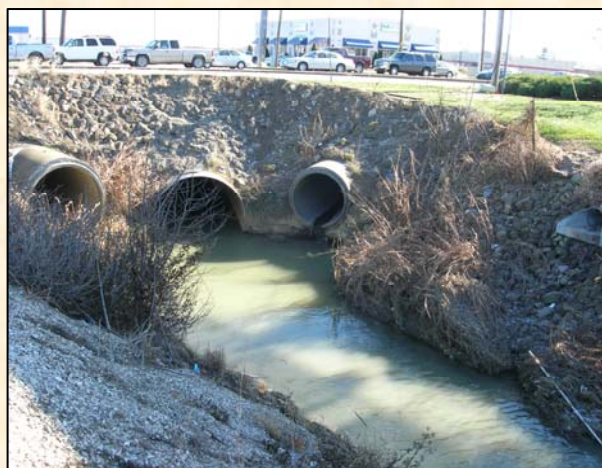
**Figure 2 East Side Urban—Hirsch Ditch  
West Side of Green River Road  
Looking East**

The American Structurepoint's **hydraulic** study recommends specific improvements to keep the Hirsch and Harper ditches functional and to reduce flood potential during the 100-year frequency storm event east of Green River Road. The study recommends replacing three of the five culverts in Hirsch upstream of Green River Road at an estimated cost of \$822,000. The Surveyor and American Structurepoint have obtained all the required permits for INDOT to proceed with the first culvert replacement at Green River Road and Morgan Avenue. The study includes a recommended culvert size, which has been incorporated into INDOT's project design. American Structurepoint's study also identifies all critical areas where stream bank failures and potential obstructions would cause temporary flooding and makes recommendations to improve effective channel conveyance functions and ensure fully open waterways.

The consultant's study of **sediment and trash accumulation** recommends that Hirsch be dredged in conjunction with the culvert replacements to better maintain a uniform grade. A uniform grade will eliminate the large pockets of standing water that can become mosquito-breeding habitat. The channel should be re-graded between the Green River Road and the upstream railroad spurs along State Road 62. Possibly, a community volunteer organization could be enlisted to gather debris in and around the drain during low-flow periods.

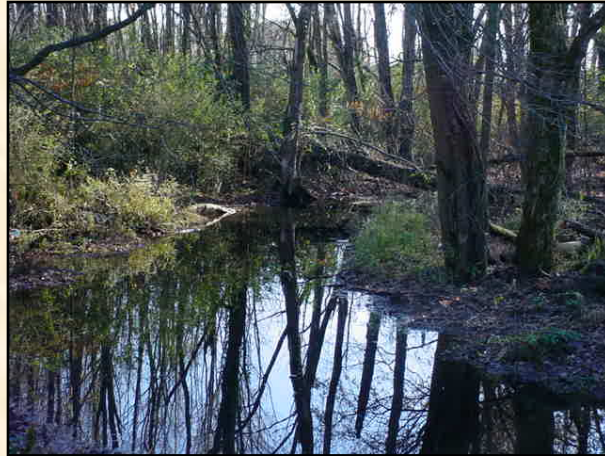
In addition to problems with Kolb ditch as defined by Wessler and Associates within the study area, an inspection crew found wood vegetation covering Kolb legal drain south of the levee, probably the result of the tornado.

**Figure 3 Kolb Legal Drain South of the Levee**

In addition, Kolb requires mechanical removal of silt and heavy vegetative debris, which is not included in the above costs.

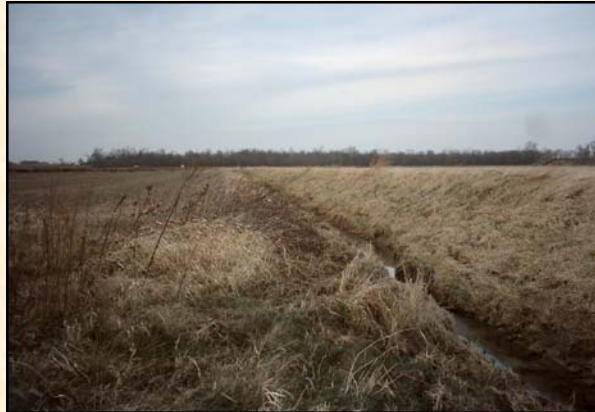
**Pond Flat Main**, from its easternmost point at U.S. Highway 41, downstream about 3,000 feet to the CSX Railroad, needs reconstruction as recommended by the Surveyor. The channel is

undersized and the elevation of the embankments is unequal on each side, forcing flood water out at various points in an erratic manner during high water events. The plans show widening the ditch bottom to ten feet and laying the ditch banks back at a 3:1 slope. If the railroad bridge were reconstructed to allow passage of the 100-year storm flow, as the IDNR requires of modern bridges, the reconstructed channel would contain and convey the 100-year storm run-off. However, CSX refuses to discuss such an improvement of its bridge and insists on constructing another bridge with

**Figure 4 Pond Flat Main - West Towards CSX Crossing near Hwy 41 South Bound Bridge**

Clark Dietz has developed plans for the reconstruction project, and obtained the environmental permits necessary to initiate the work. The only items remaining are a field meeting with IDNR to go over the plans; a public hearing to view the plans and the estimated costs; and the development of specifications for contractors to bid. The estimated cost of the project exceeds the current account balance, which means there is the possibility the properties benefited would have to pay an increased assessment to cover the cost of construction. The public hearing would be the proper venue to discuss issues such as an increased assessment.

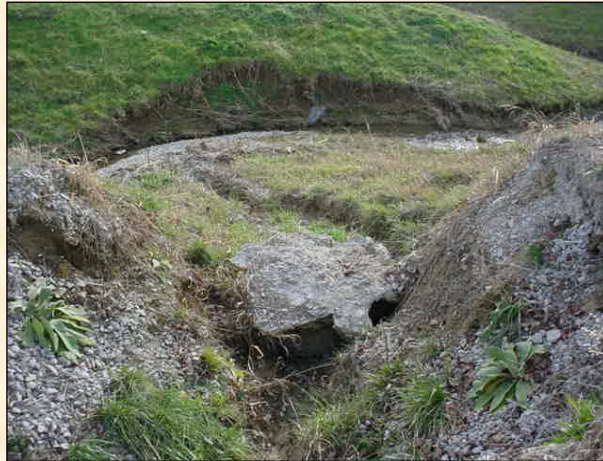
**Figure 5 Severe Erosion Along East End of Sonntag-Stevens**

- Soil erosion (exposed soil or head cutting bank failure and sediment deposition) was observed in four areas and considered excessive.
- Japanese Honeysuckle (*Lonicera japonica*), a non-native invasive plant was observed in six areas on the site. Although the vegetation was not observed to impede the

Furthermore, a recent infestation of cattails, particularly, downstream of the intersection of Hitch Peters and Lynch Roads require intensified herbicide applications in 2008. The Surveyor will include future projects to address bank failures, sediment removal, and better vegetation cover.
